NASA Contractor Report 4676

# Effect of Open Hole on Tensile Failure Properties of 2D Triaxial Braided Textile Composites and Tape Equivalents

*Timothy L. Norman, Colin Anglin, David Gaskin, and Mike Patrick*

Grant NAG1-1381  
Prepared for Langley Research Center

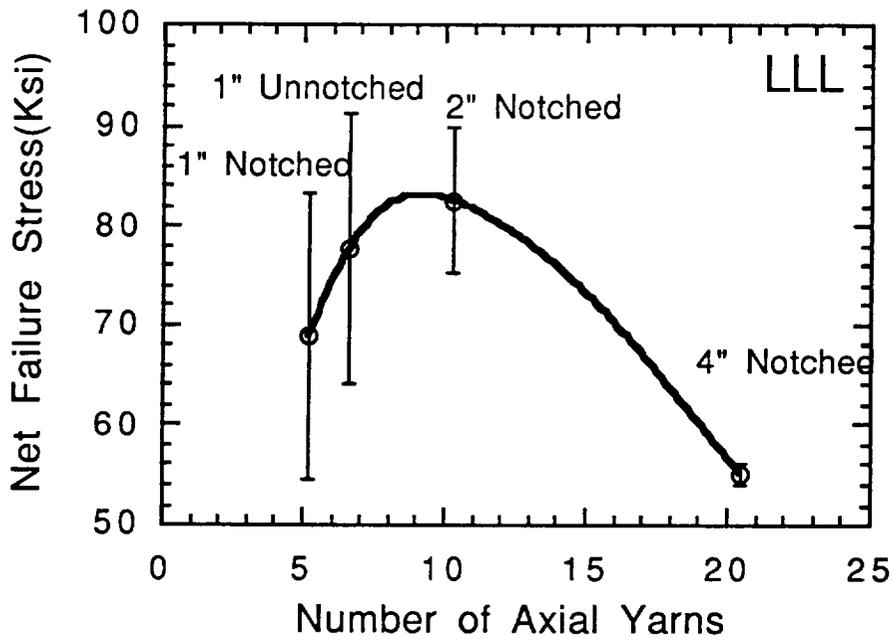
Figure 28. The competing sensitivities of notch size number of axial yarns suggesting that net section width of near 1.5" coupons should be minimum for LLL.
